# **Navajo Abandoned Uranium Mine**

## **Site Screen Report**

**Mine Name: Jack Daniels No. 5**  
**Mine ID: 545**

**August 2011**

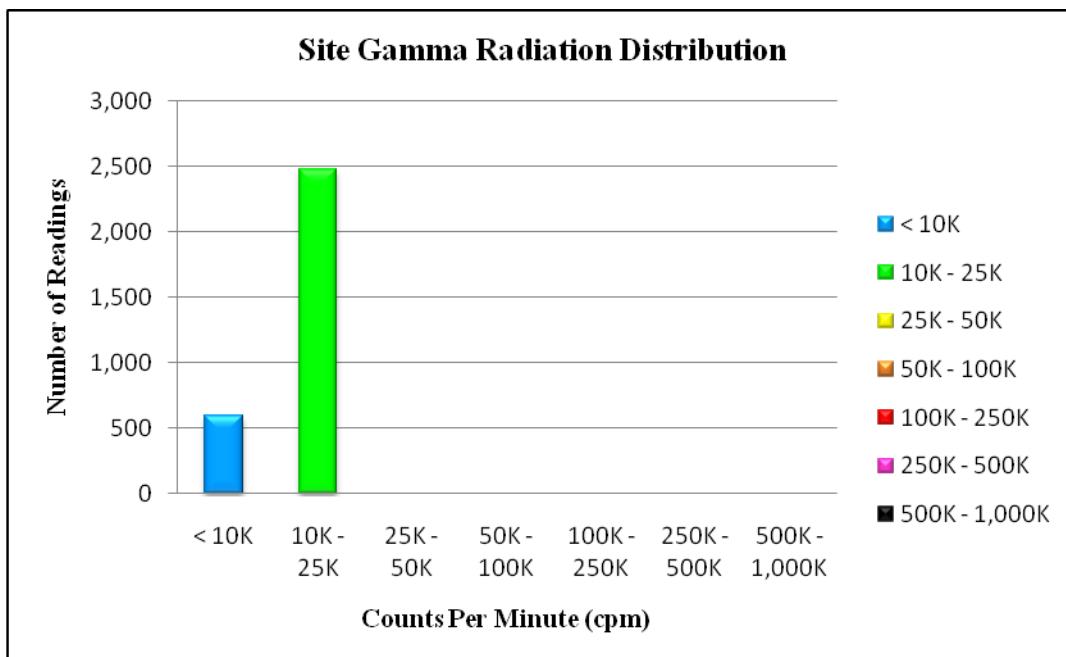
**Highest gamma radiation measurement:** 19,688 counts per minute (cpm)

**Background Average:** 15,017 cpm        **Two Times Background:** 30,034 cpm

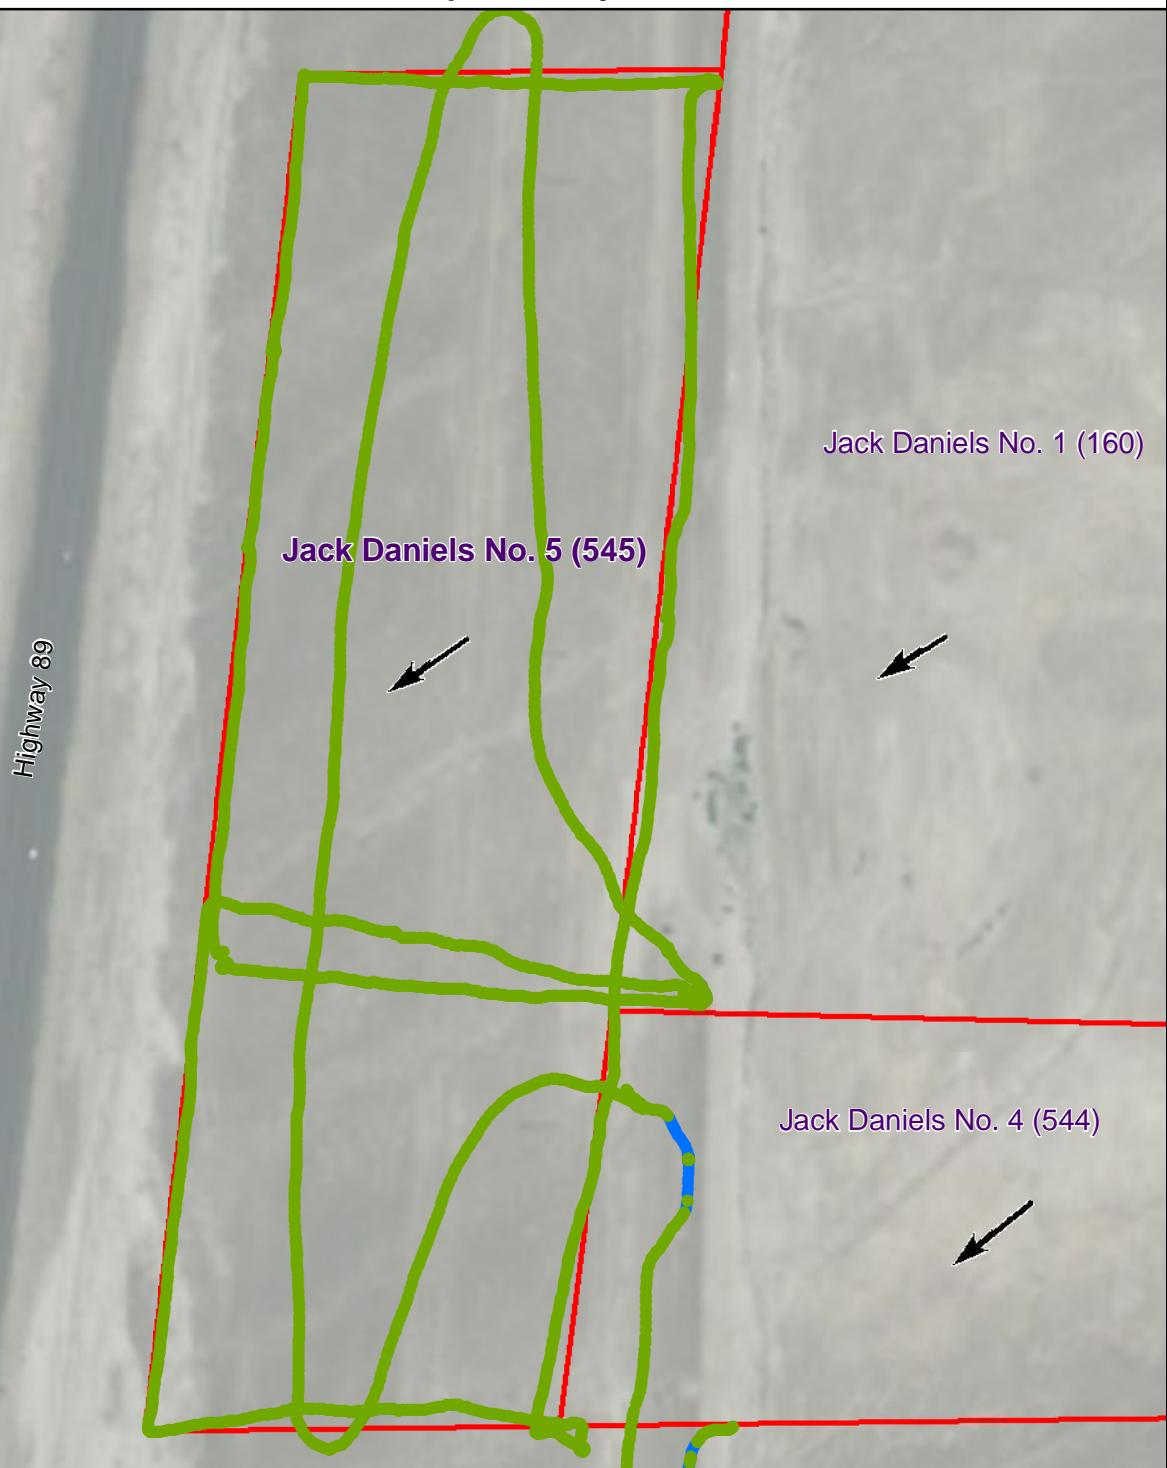
**Figure 1 - Gamma Radiation Measurements, Above Two Times Background**  
**Jack Daniels No. 5 (545)**  
**Coalmine Mesa Chapter, Navajo Nation**

A total of 3,072 gamma radiation measurements were collected from the mine site, ranging from 5,878 cpm to 19,688 cpm. The measurements are represented in Figures 1 and 2.

**Were any gamma radiation measurements collected at the mine greater than two times the site-specific background levels?**

No
